THE PROBLEM SOLVER®**PROBLEM:****Lower Ball Joint Failure**

SOLUTION:**MOOG® Problem Solver®
K7467 Lower Ball Joint**

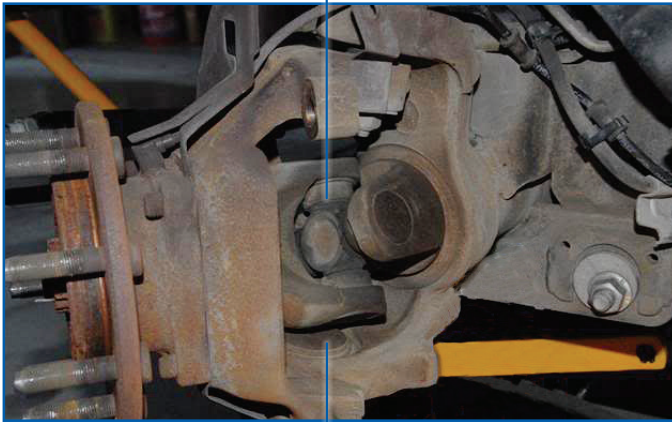
OE and other suppliers' designs can lead to early failure in vehicles that are subject to adverse road conditions or severe duty use.

- Plastic bearing is subject to excessive wear.
- No provision for preload can lead to excessive deflection and degradation of socket torque as the bearing wears.
- OE ball joint is non-greaseable, and the tight installation clearance makes servicing other suppliers' ball joints difficult.

OUTER U-JOINT

NOTE LIMITED CLEARANCE

In order to remove and install the lower ball joint, the knuckle must be removed. We recommend that you replace the outer universal joints at this time, as they are easily accessible during this procedure.

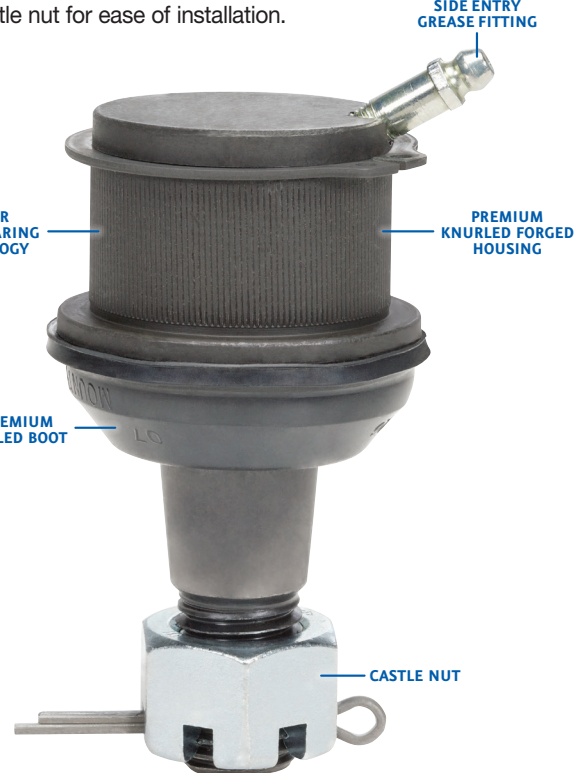
- Exclusive powdered-metal "gusher" bearing improves wear resistance and durability.
- Belleville washer ensures proper preload and consistent socket torque for the life of the part.
- Premium knurled housing ensures strength and a secure installation.
- Premium black polychloroprene boot lasts longer than blue neoprene boots.
- Side-entry style grease fitting allows easy service of ball joint while on vehicle.
- Castle nut for ease of installation.

GUSHER
METAL BEARING
TECHNOLOGYSIDE ENTRY
GREASE FITTINGPREMIUM
KNURLED FORGED
HOUSINGPREMIUM
SEALED BOOT

CASTLE NUT

The MOOG® Problem Solver® K7467 ball joint features many improvements over the OE and other suppliers' ball joints.
